Figure E-1: Looking upstream at Macallen Dam from downstream footbridge. Photograph taken 10/4/2013.

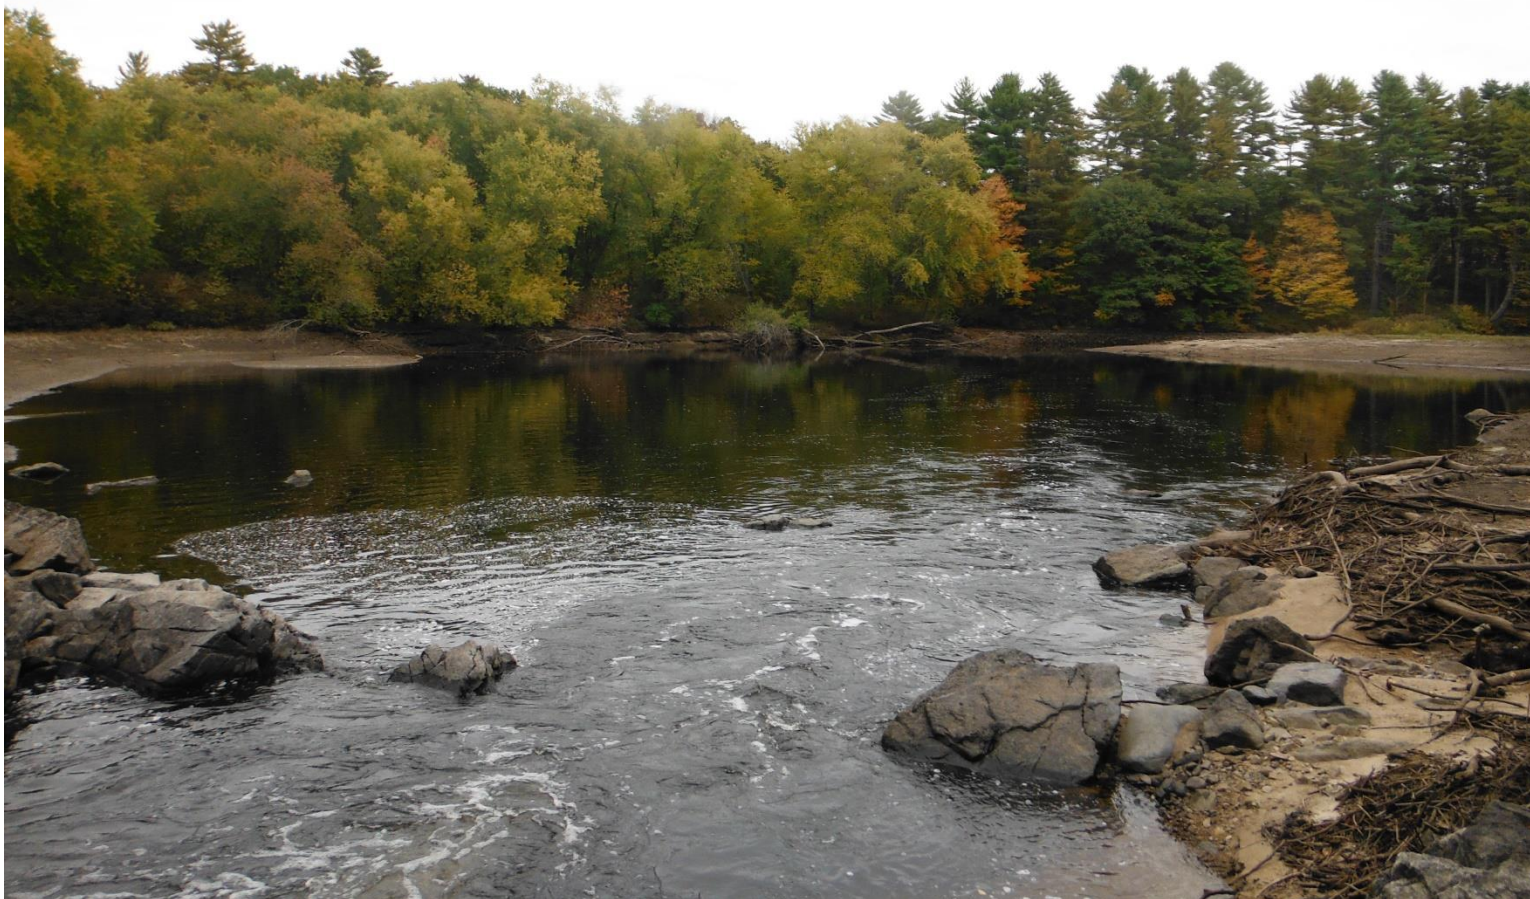
Figure E-15: Looking downstream at the large pool below Packer's Falls. Photograph taken 10/5/2013.

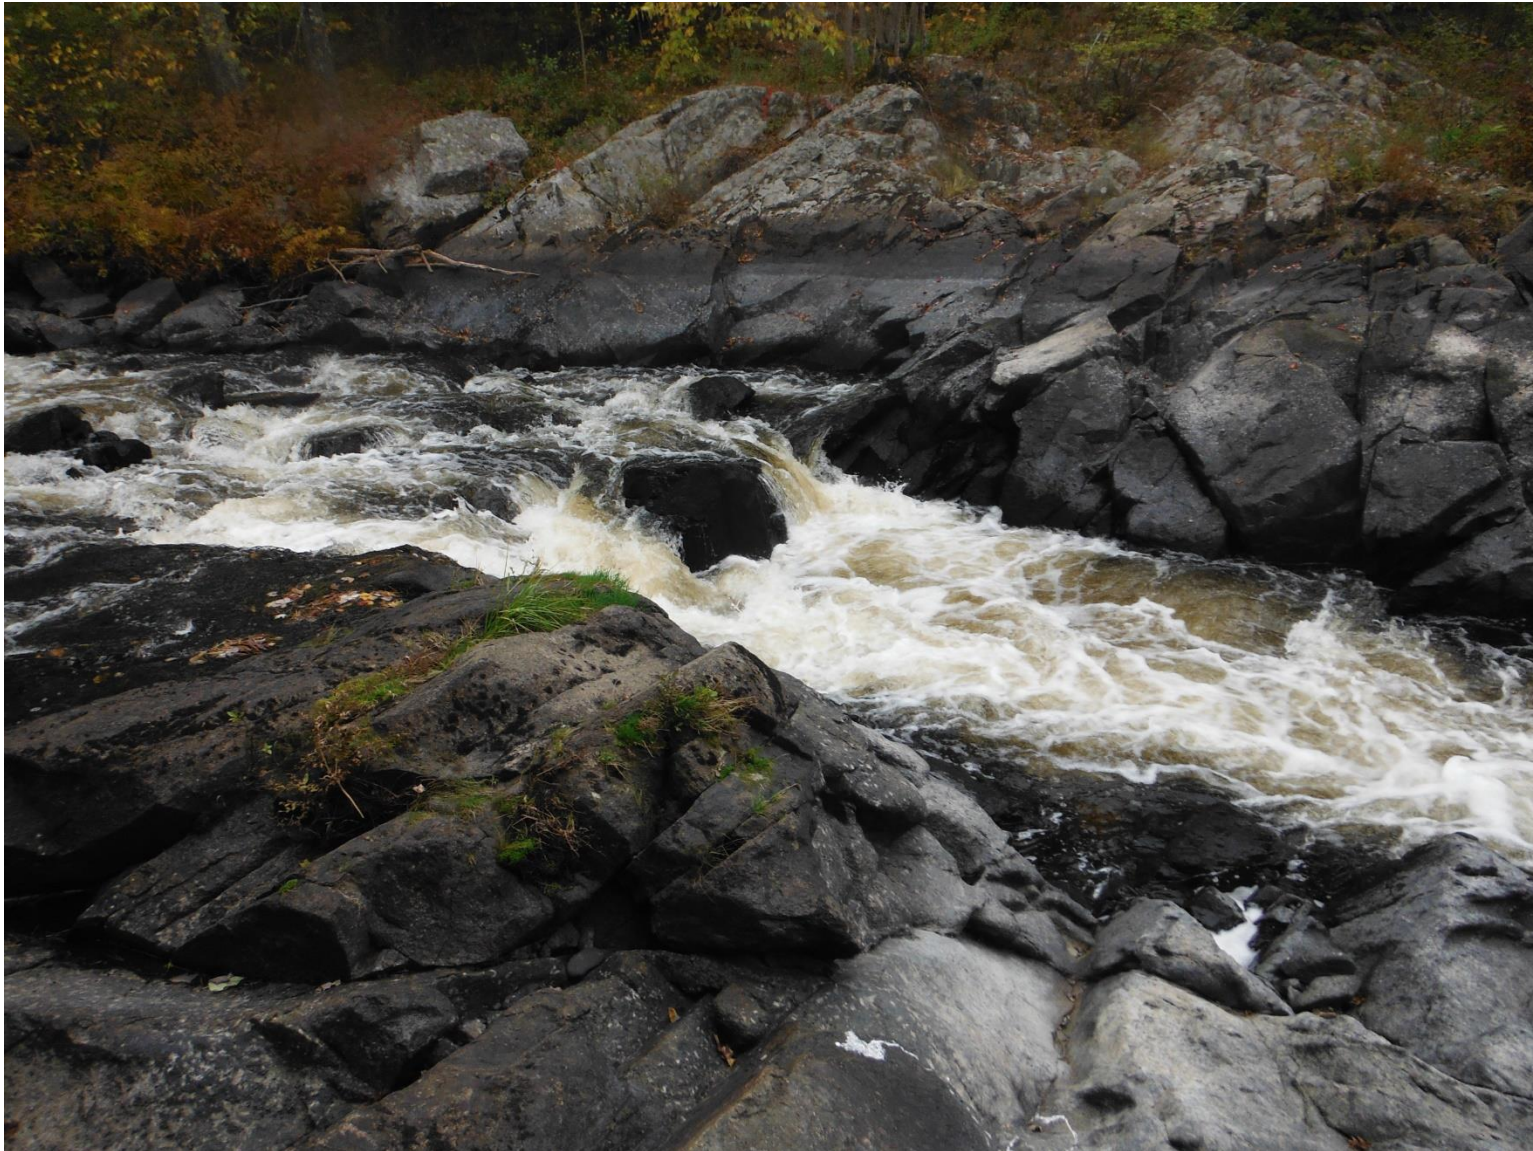
Figure E-16: New waterfall/rapids section at the normal impoundment upper extent. Photograph taken 10/5/2013.
